X-RAY COMPUTED TOMOGRAPHY FOR FAILURE ANALYSIS

Richard H. Bossi
Alan R. Crews
Gary E. Georgeson

Boeing Defense & Space Group
P.O. Box 3999
Seattle, WA 98124

Interim Report for Period May 1991 to January 1992

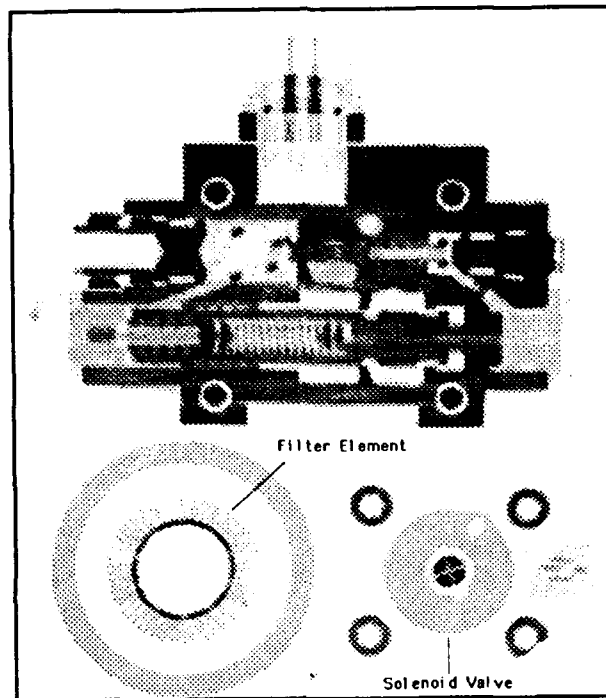
An autobrake unit, that was experiencing out-of-specification hydraulic pressure response, was evaluated radiographically, but the images contained a confusion of features with very poor sensitivity to internal detail. Digital radiography (DR) was also performed on the unit and compared to the film radiograph the DR was clearly superior for this analysis. However projection radiography of a complex component is not sufficient and in fact showed convincingly that CT or disassembly would be required to determine the failure mechanism of this assembly.

Figure 3.1-4 CT slice through the autobrake module at the height of the pressure control servovalve.

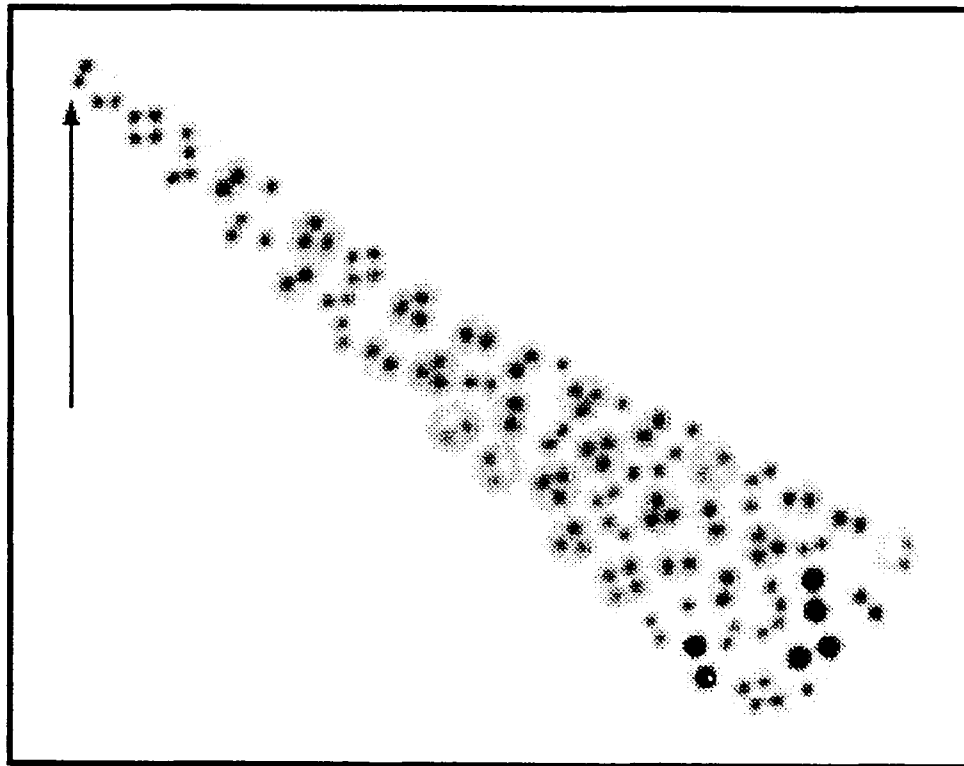
The first failed cable was CT scanned in a nine-slice CT series on steps of 1 mm. This scanning sequence covered a discolored region on the cable. Figure 4.2-1 is one image from this series. This image shows where the twisted pair on the thin side (pointed end of the trapezoid cross-section) edge had been compressed over about a 2-mm (0.08-in) length. The compression is a likely cause of insulation thinning which would have resulted in the Hi-Pot failure. The CT image also shows that there is marginal room in this assembly for the number of wires required. The wires are pushing the outside envelope of the potting; in addition the narrow edge does not have adequate room for the twisted pair. This is going to be a recurring problem area for damage from manufacture and handling for this design. Figure 4.2-2 is a CT slice taken near the termination of the cables to connectors. The image indicates a poor distribution of wires in the cable as noted by the large region containing no wires.

Figure 4.2-1 CT slice through the raceway cable in a region of surface discoloration for a failed cable.

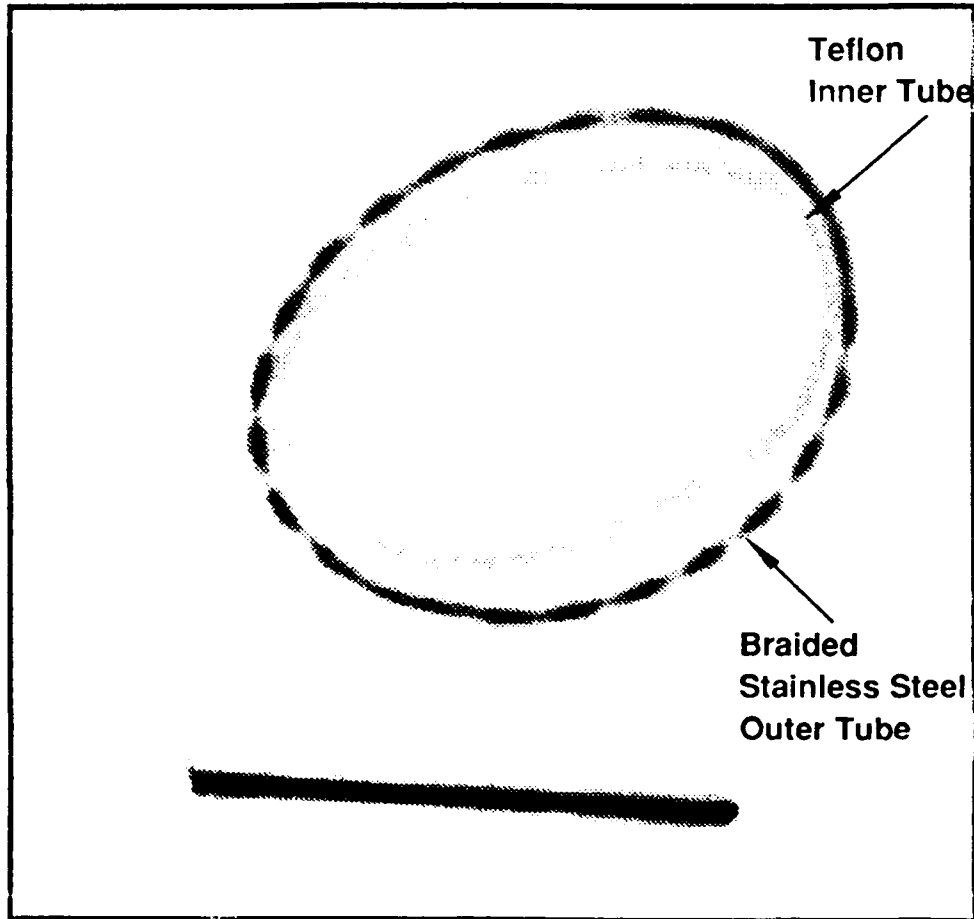
Figure 5.2-1 is a CT image of the fuel line at the maximum point of crush under vacuum, Figure 5.2-2 is at the same location at ambient pressure, and Figure 5.2-3 is the same location at full operational pressure. The CT images show how the inner and outer tubes behave relative to one another under the three pressure conditions. From this set of CT images, it was concluded that this fuel line could not have collapsed, and the ultimate finding of the investigation was that it was another section of fuel line that collapsed, causing the engine malfunction.

Figure 5.2-1 CT slice of a fuel line under vacuum conditions (2X actual size) showing teflon inner tube and braided stainless steel outer tube.

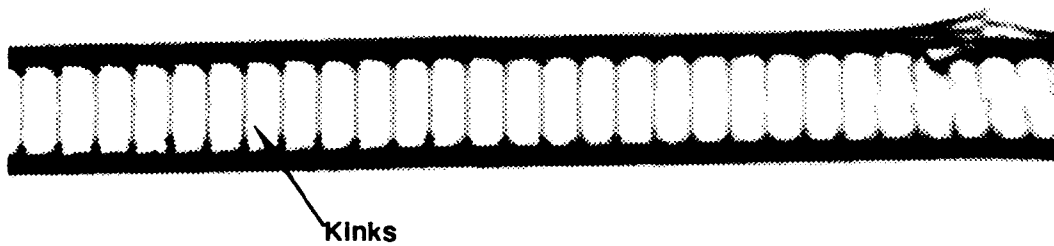
Figure 6.1-7 shows the left half of the image from slice location D. The features are equivalent to those identified in Figures 6.1-5 and 6.1-6. The only difference is that the kinking in the core walls is slightly more prominent and extends across the length of the left side.

Figure 6.1-7 CT slice at location D.
